# BRANZ STUDY REPORT

## *A SURVEY OF MOISTURE DAMAGE IN SOUTHERN NEW ZEALAND BUILDINGS*

H.A. Trethowen and  
G. Middlemass

BRANZ Study Report SR 7

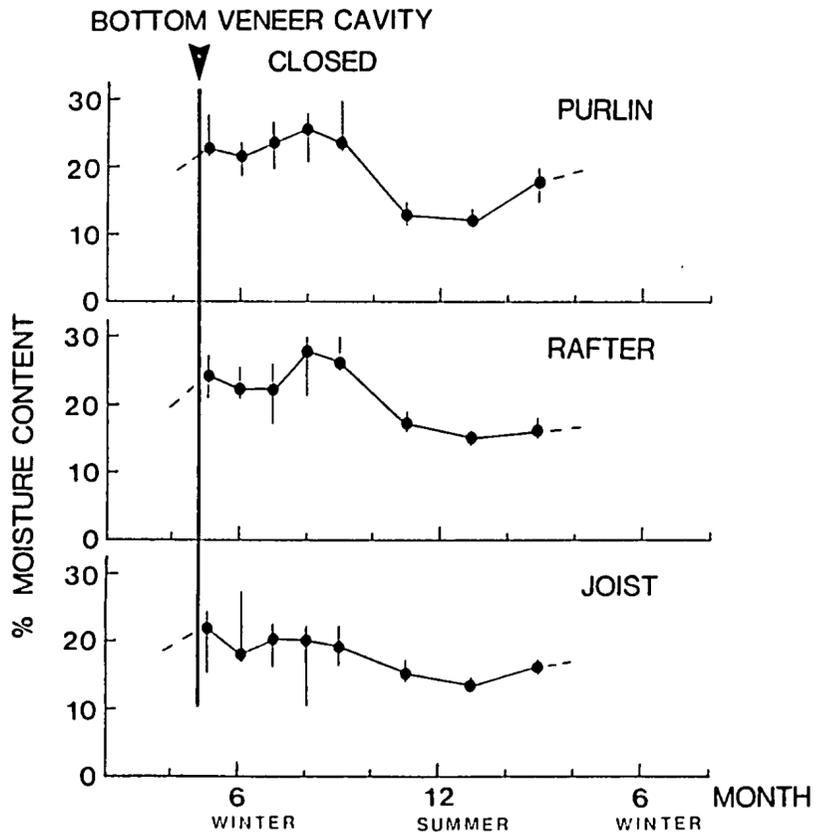
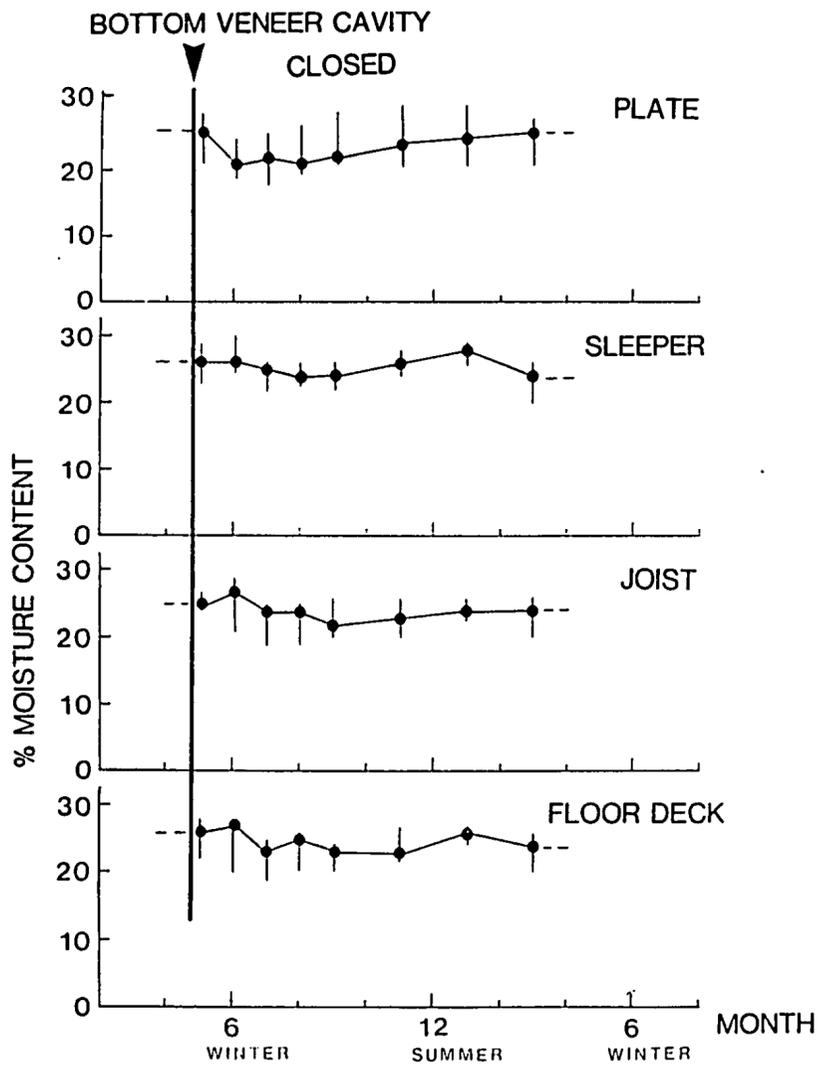
The responses differed quite markedly, with the roof space of house 5 remaining at relatively high moisture contents throughout the winter, and that of house 6 drying out as rapidly and as positively as in houses 1-4. Both roof spaces were dry during the summer.

Both floor spaces remained at high moisture content through the entire programme, summer as well as winter. Moisture content

scarcely dropped below 20% at any time, and in a number of places remained over 25% for lengthy periods.

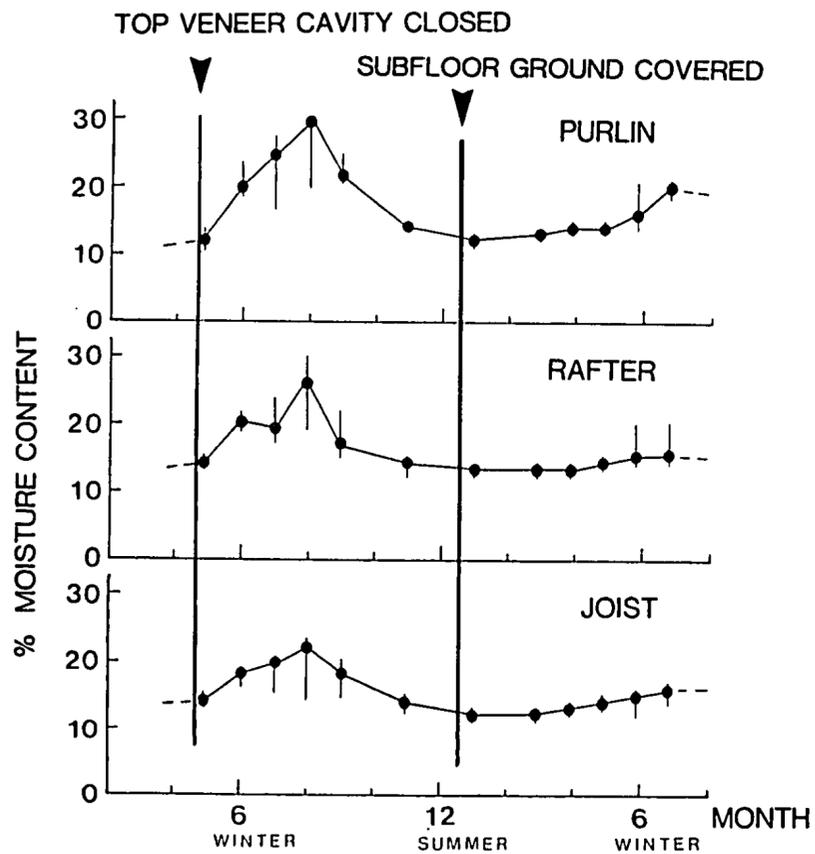
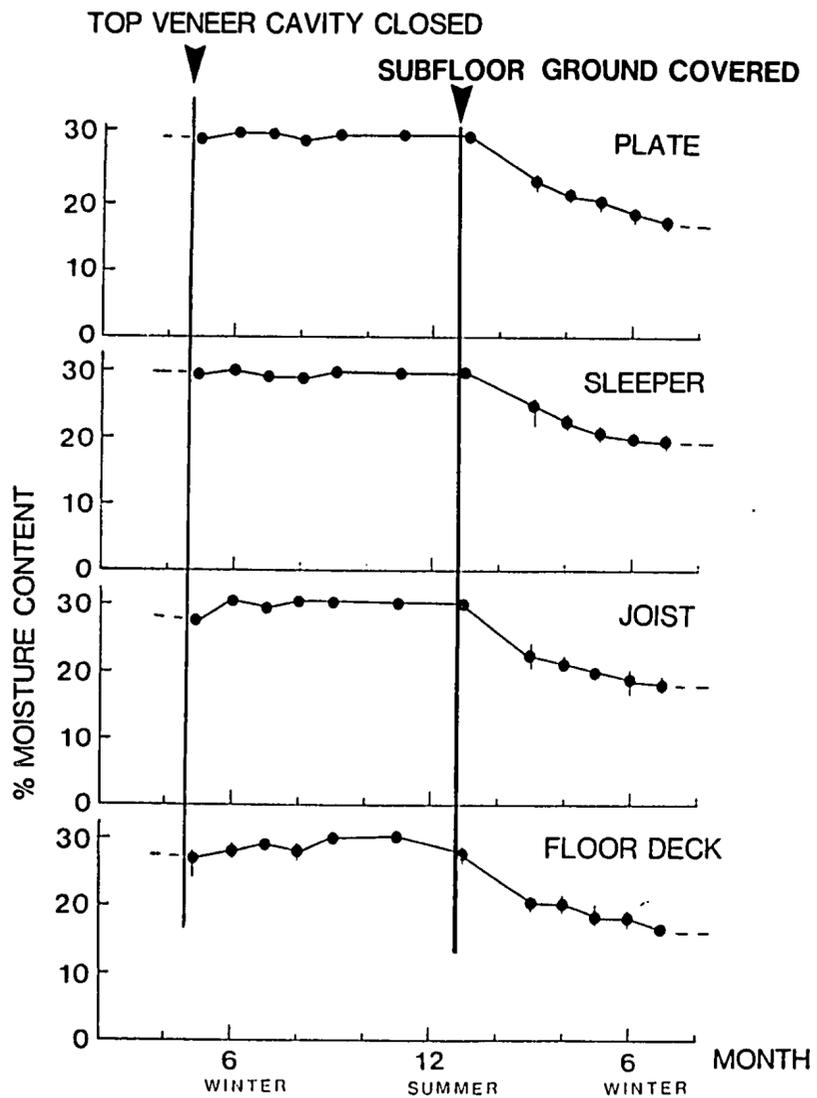
These two houses were treated by blocking the veneer cavity at eaves level, and neither appeared to gain any value from the treatment. Moisture behaviour through the winter was typical of the many untreated houses in the district.

In both houses, roof space moisture contents rose to very high levels in winter and remained at those levels for most of the winter. The wettest timbers were those closest to the roof: purlins, rafters, joists - in that order. There were common sightings of extensive visibly wet areas within the roof, with the inspector estimating that 50% of all purlin surfaces and 20% of rafter surfaces were wet or dripping. Roof underlay over most of the roof was reported visibly wet or dripping on several successive monthly visits. Both roof-spaces dried out to the same state as the other eight during summer.

In both subfloor spaces the timber remained at very high moisture content, at or close to 30% at all locations, summer and winter.

There was a prompt and permanent change in behaviour when the ground under these two houses was covered, during the summer. All subfloor timber m.c. began immediately to fall, by some 2% - 3% per month, to at least 10% below their previous level, where they remained. During the following winter, the roof space moisture content rose, but substantially less than in the previous winter. Visibly wet patches were seen once, in one house, and then only briefly. Otherwise, timber, ceiling insulation, and roof underlay were all reported as "warm and dry to touch", through the winter.
