INTERNAL MOISTURE

SERIOUS CASE OF MOISTURE

Taking the presumed warmer, drier air from the roof space in an older era house certainly didn't have the expected effect for one family. Serious internal moisture problems resulted... and they aren't alone with this problem.

By Richard Popenhagen, Eco Building Design Adviser, Nelson City Council

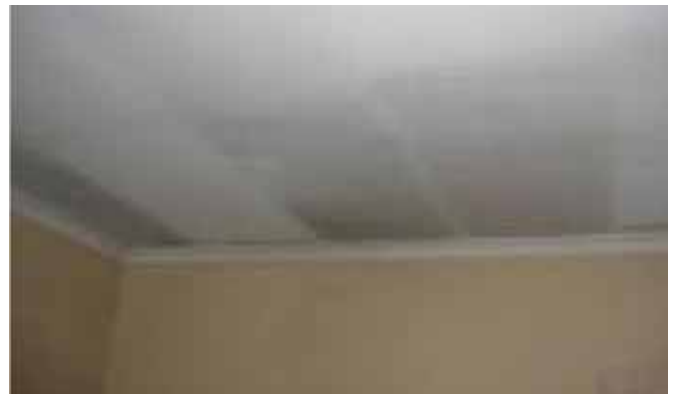
For mould to grow, the relative humidity at surfaces only needs to be above 80%. Figure 2 shows mould stains on a ceiling. Here the relative humidity near the ceiling under the joists is below 80%, whereas the relative humidity near the ceiling where there is no insulation is above 80%. Mould grows on this part of the ceiling because the surface is colder.

Figure 2: Mould growth causes staining on a ceiling.

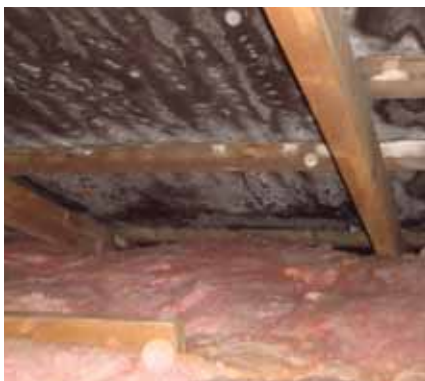
The owner of the 3-bedroom family home had noticed a serious moisture problem in the roof space. Large amounts of moisture were accumulating on the underside of the roofing underlay, turning to ice on cold winter nights and dripping onto the ceiling insulation when thawing the next day. Timber roof members were wet, and mould was growing on the purlins.

Figure 1: Moisture is clearly visible on the roofing underlay.

Another likely contributor to the problem was that the roof access hatch is situated in the bathroom, allowing bathroom moisture to be drawn around the edges of the hatch cover into the roof space by the negative roof space pressures. This moisture-laden air was condensing on the cold surfaces of the roofing underlay and roof timbers (see Figure 1).

As a result of the findings, the owner was advised to:

- turning the roof space ventilation system off
- install a ground moisture barrier over the ground under the house
- consider installing a bathroom extractor fan ducted to the outside to

remove bathroom moisture from inside the house

- treat and remove all mould from any interior surfaces.

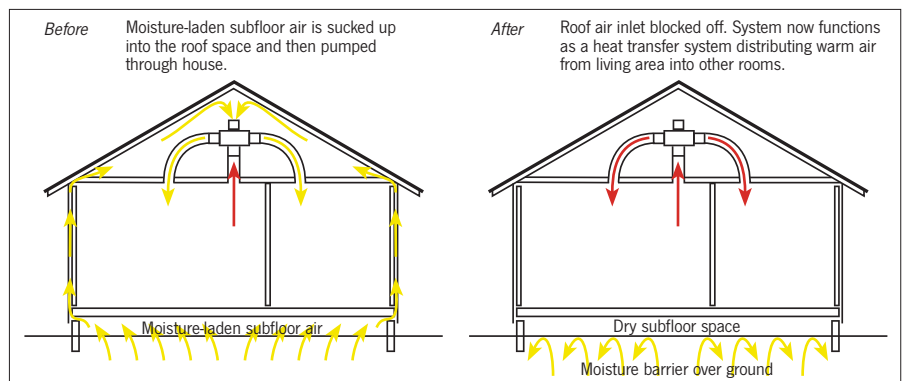
Figure 2: The problem and solution for the 1900s Nelson house.

The roof space ventilation system was creating a negative pressure in the roof space. These systems can move large quantities of air, and in the Nelson house, some of the air drawn into the roof space to replace the air being pumped into the house was moisture-laden subfloor air, drawn up through the wall cavities.

Ultimately, the homeowner had the system modified, blocking off the inlet from the roof space, and now runs it purely as a recirculation device that takes warm air from the living area and transfers it to cooler parts of the house (see Figure 2).

A ground moisture barrier has been installed under the living room with plans to extend it to under all areas of the home by next winter, and the underside of the floor has been insulated.

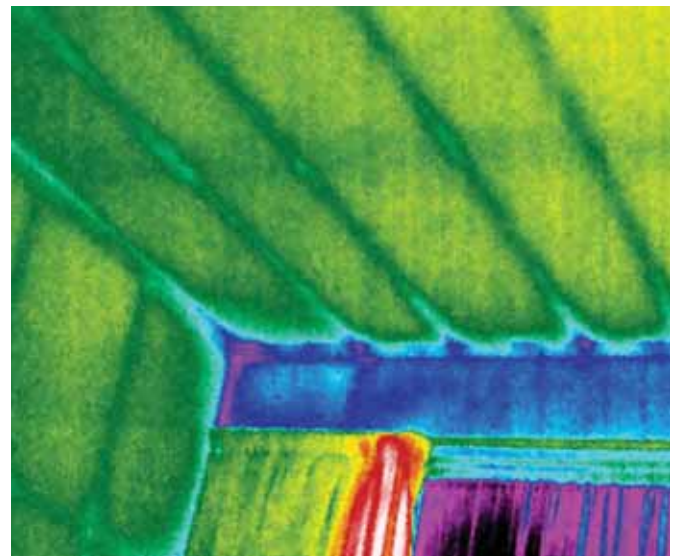
Classical thermal bridging occurs when the building envelope is bridged by a high thermal conductivity rafter (see Figure 1). Figure 2 shows an infrared thermograph of a ceiling with thermal bridges at the joists identified as areas of lower surface temperatures.

Figure 2: Thermograph of a ceiling showing cold bridges at the ceiling joists.

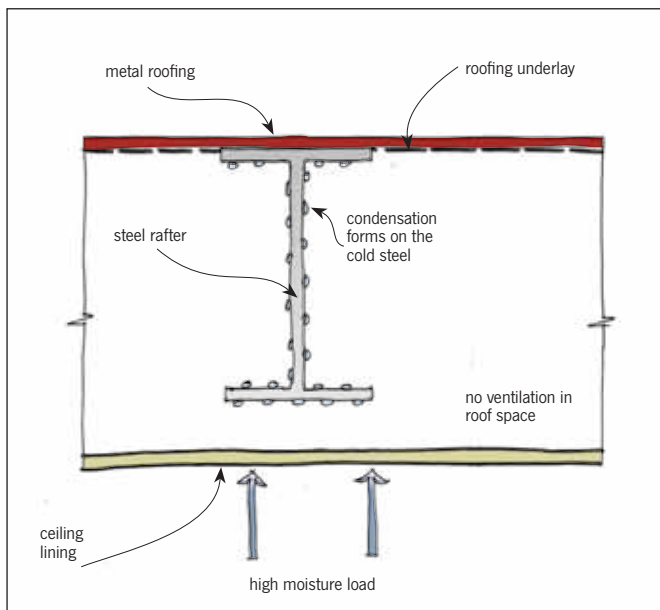
Aggravated thermal bridging is more subtle than classical bridging because the bridging element is only in touch with the roof – it doesn't touch the ceiling as well (see Figure 3).

The roof design of the institutional buildings in which aggravated thermal bridging has been identified is reasonably common. Condensation problems have not always been seen. However, condensation, sometimes quite heavy, has been observed on the steel element in the roof – in some cases, this has led to serious levels of corrosion. Several aggravating factors have been identified as contributing to the problem:

- Steel in direct contact with a low-temperature thermally conductive metal roof (usually with an intervening underlay that has no thermal benefit).
- High R-value (0.3–0.5 m²C/W) ceiling tiles – these thermally isolate the steel element from the warm interior, allowing the steel to approach the temperature of the cold roof cladding.

- Steel elements thermally isolated from a warm room – below the steel element and above the ceiling is an air gap or sometimes a timber packing that has sufficient R-value to further thermally isolate the steel from the warm occupied space.
- High internal moisture loads from 20–30 people in a relatively small space.
- Air-permeable ceiling allowing moist air to easily move into the roof cavity.
- Airtight metal roof cladding meaning there is little air movement through the roof.
- No purpose-designed ventilation with no ceiling, roof or ridge ventilators.

Figure 3: 'Aggravated' thermal bridging – the bridging element is in touch with the roof only.

A solution is to use a high R-value, high-vapour resistant insulating layer, for example, polystyrene or phenolic insulating boards (see Figure 4 schematic). This provides a much higher level of overall roof R-value, resulting in significantly higher steel temperatures. The high vapour resistance is required, otherwise there will be very high levels of condensation in the underlay and under the now very cold metal roof, particularly because ventilation immediately under the roof is very low. ◀
