STUDY REPORT

SR 233 (2010)

Investigation into the Performance of Urea Formaldehyde Foam Insulation

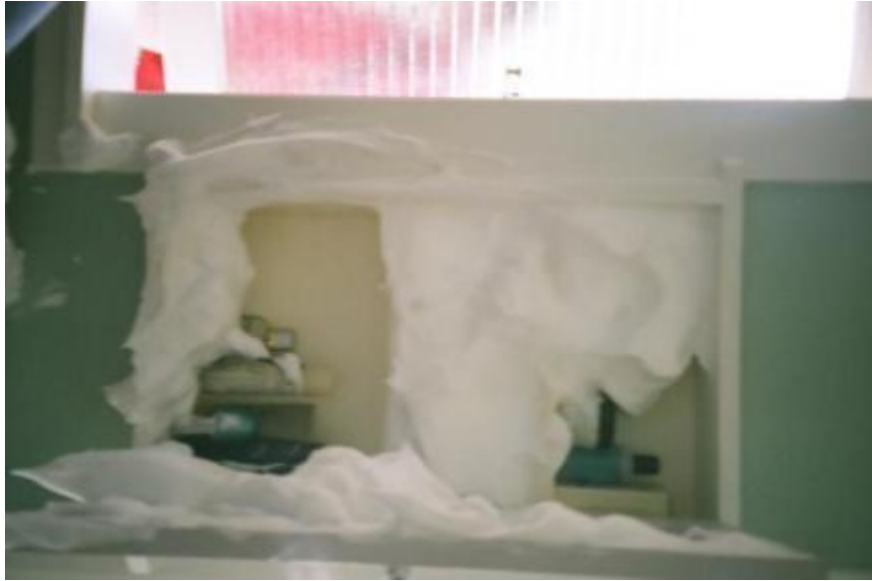
Although there have been a few reported cases where the Airfoam installation process has been problematic, such as in the case observed in Figure 1 and Figure 2, it appears that these cases are relatively rare occurrences. These issues are usually a result of installer error or lack of robust assessments prior to installation.

Figure 2: Example of serious installation problems (House W7)

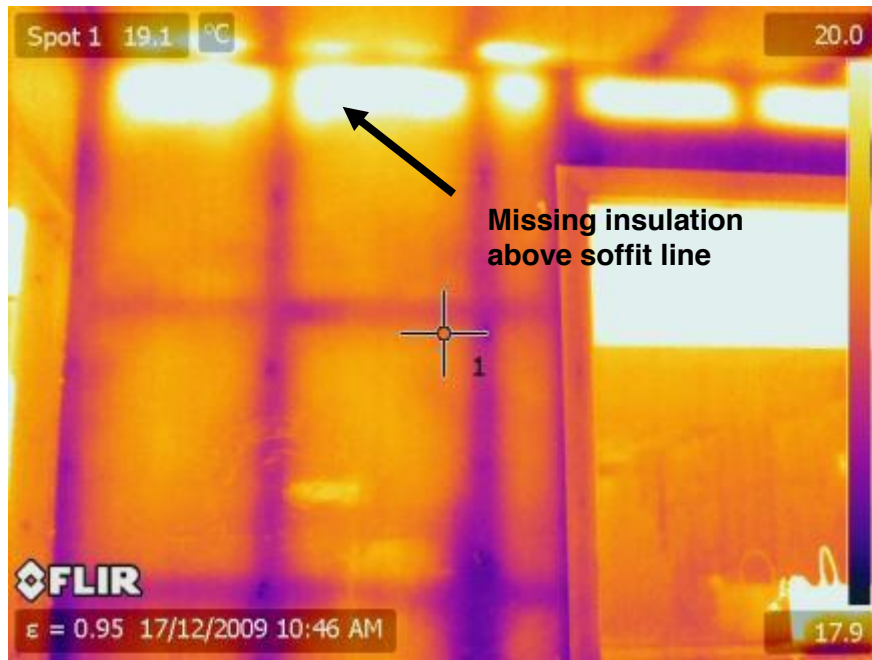
Figure 4: Thermal image identifying missing insulation in another upper wall above the soffit line (House C7)

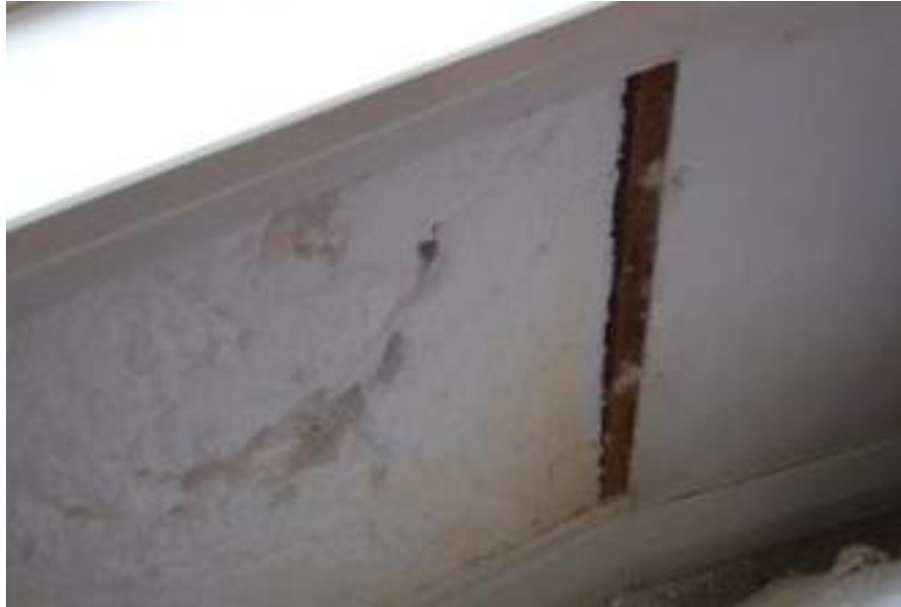
(House W3) *A weatherboard / stucco house with building paper, insulated in August 2008.* The thermal imaging again showed that the Airfoam installation was inconsistent in many areas of the house, which was confirmed when some of the wallboards were removed in the bedroom. The samples showed shrinkage from the framing and voids in some areas, which would undoubtedly compromise the thermal performance of the insulation. These samples were used in some of the laboratory tests.

Figure 10: Removal of wallboard to assess Airfoam installation – note voids present house (House W3)

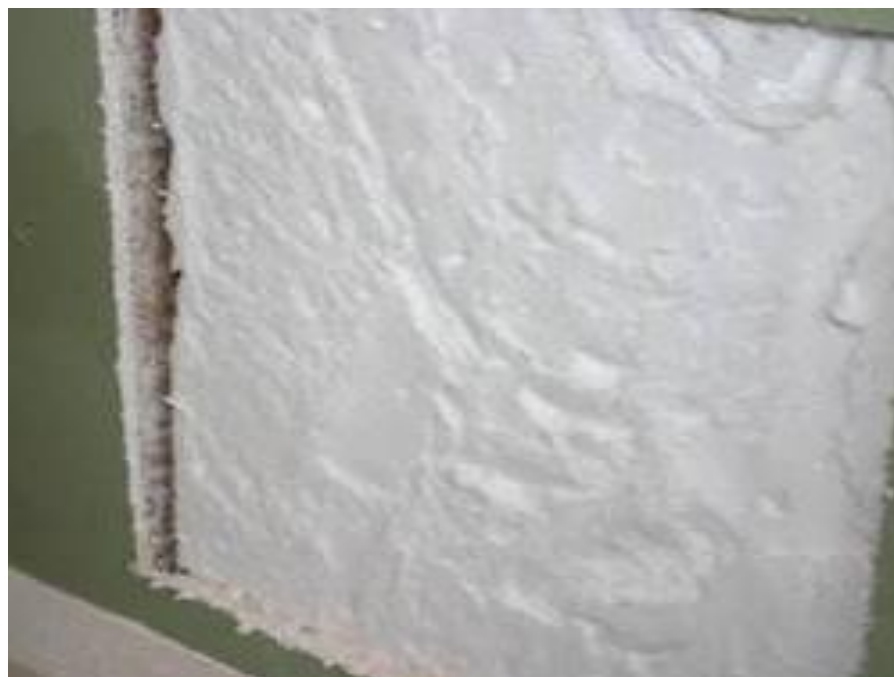
Figure 11: Removal of wallboard to assess Airfoam installation (House W3)

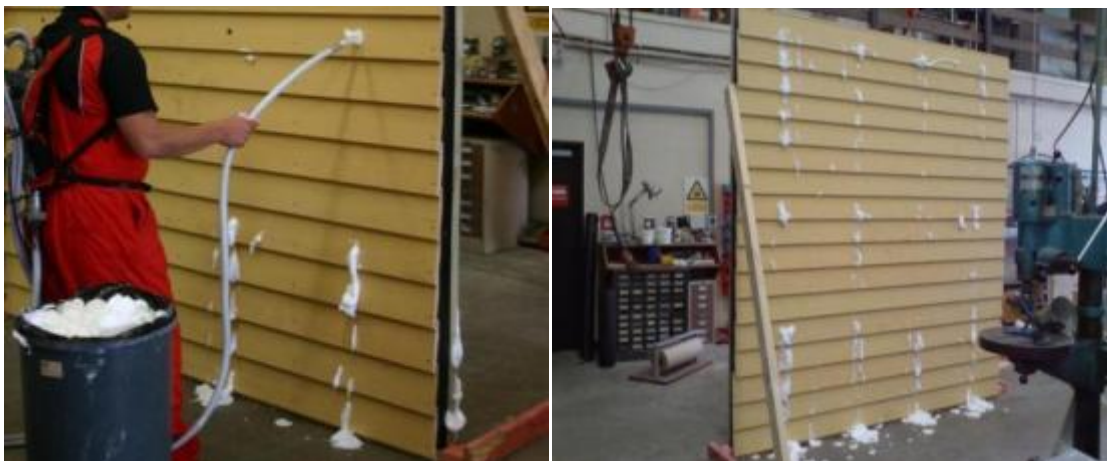
UF foam was injected into the insulation cavities, behind the building underlay, from the outside, using holes drilled through the weatherboard by an Airfoam applicator in December 2009. The specimen was then stored in the BRANZ laboratory for five weeks until being tested in mid January 2010 (Figure 13 and Figure 14).

Figure 13a & b: Installation of Airfoam in large scale test wall (D4861) at BRANZ

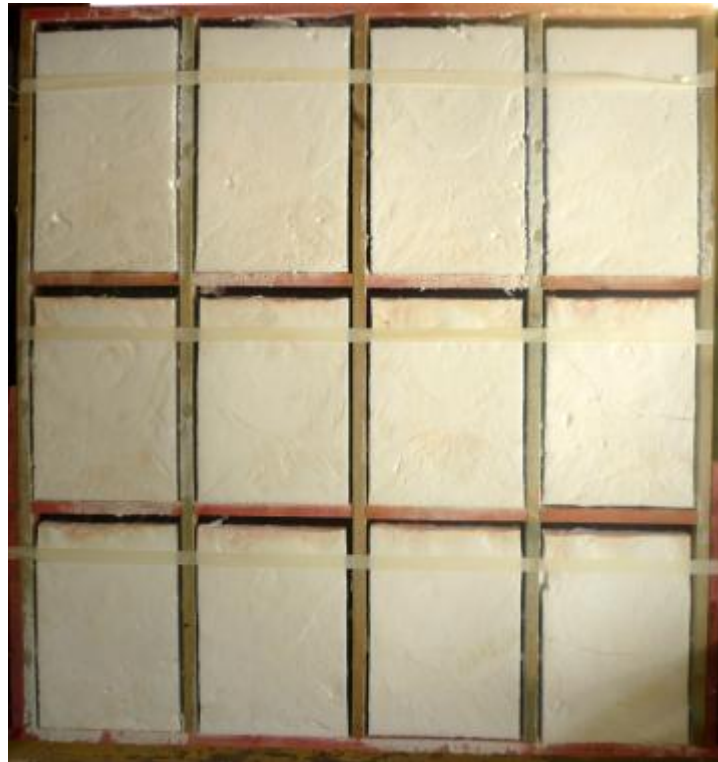
Figure 14: Test wall (D4861) after Airfoam installation and plasterboard removed

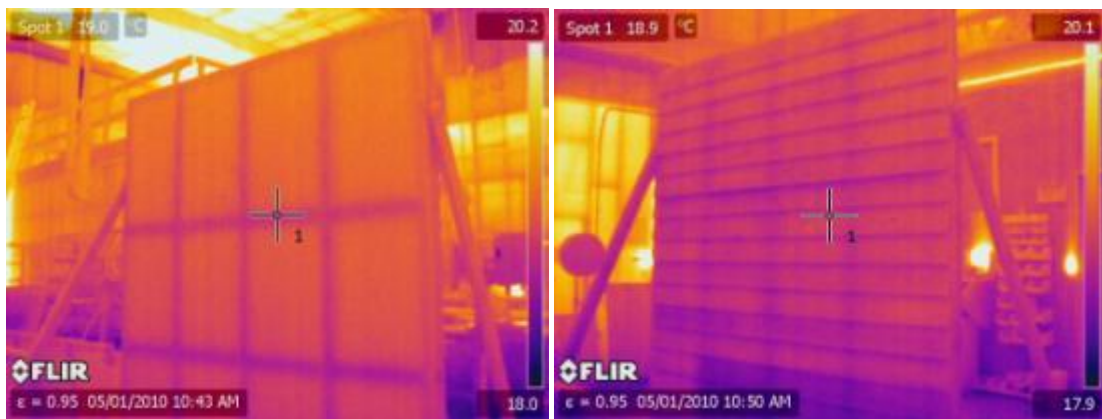
Figure 17 & 18: Thermal images of panel (D4861) immediately before thermal testing

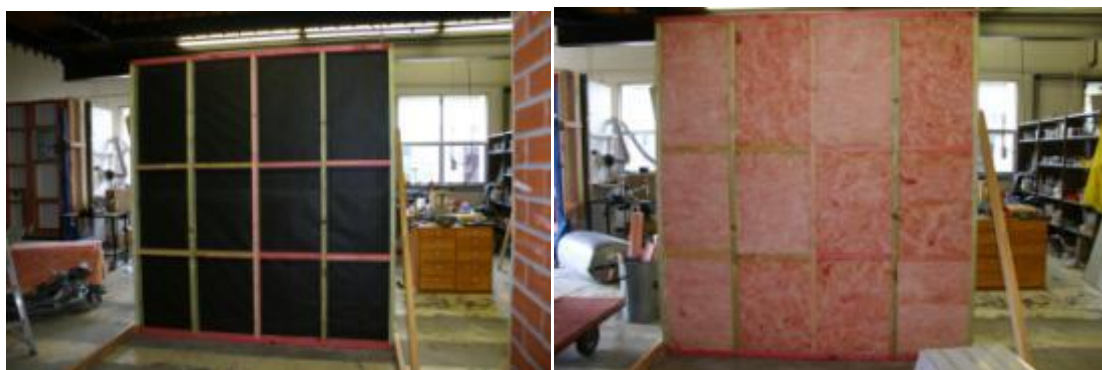
As a demonstration of the effects that shrinkage gaps can have on the thermal performance, a further 2.4 m by 2.6 m panel was constructed (designated wall D4862) and tested that was identical to the first except an R 2.8 glasswool insulation product was used instead of Airfoam. In the first of two tests (D4862a) with the panel the insulation was well fitted without gaps, whereas for the second test (D4862b) gaps representing 6% of the insulation width were deliberately created at the sides (3% either side) and top (6%) of each frame cavity. However unlike the Airfoam panel, which was expected to have shrinkage gaps between the face of the insulation and the inside face of the cladding and lining, gaps were only created around the edges of the glasswool and not against the faces (shown in Figure 17 to Figure 21).

Figure 19 & 20: Frame before insulation (D4862) and with well fitted R 2.8 glasswool insulation (D4862a)

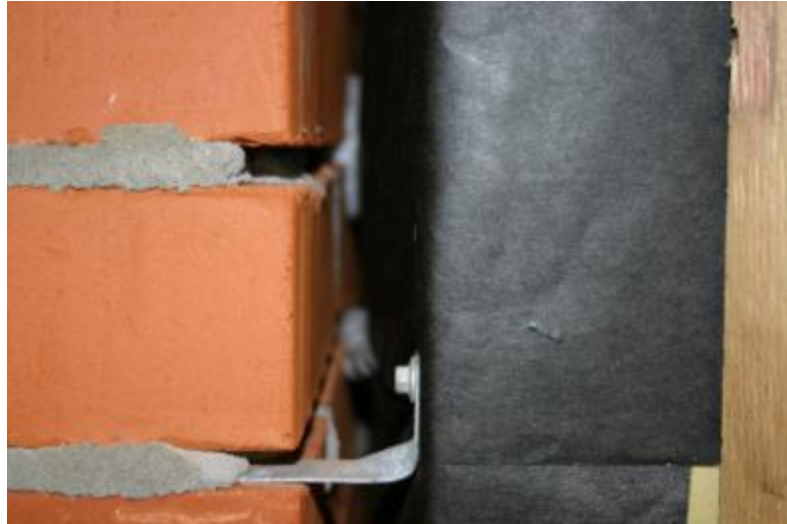
The wall sample (D4863) had a layer of black kraft paper installed against the cavity face of the framing and standard 10 mm plasterboard fixed to the other face (Figure 22). UF foam was injected into the insulation cavities, behind the building underlay, from the outside, using holes drilled through the mortar joints of the brick veneer by an Airfoam applicator on 12 February 2010. The specimen was then stored in the BRANZ laboratory for seven weeks until being tested for thermal performance in the Guarded hotbox from 1 to 14 April 2010.

Figure 22: Cavity of Brick Veneer Wall (D4863a)

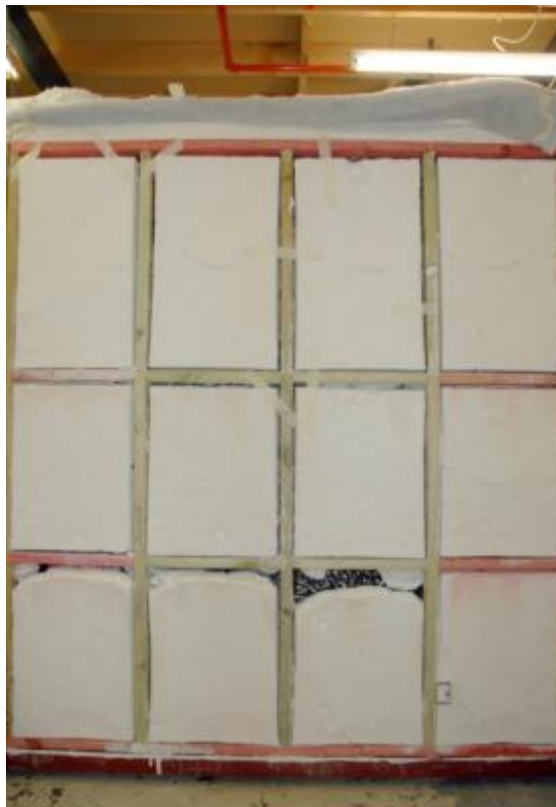
After the thermal testing, the plasterboard lining was removed from the UFFI-insulated brick veneer wall (D4863a). The UFF insulation was observed to have shrunk approximately 6% (Figure 23). It should also be noted that within one panel the UFF insulation was incomplete, resulting in a larger void. One further observation was that the installation of the UFFI caused bulging of the kraft paper and in some areas was in contact with the brick veneer.

Figure 23: UFF-insulated brick veneer wall (D4863a) with plasterboard removed

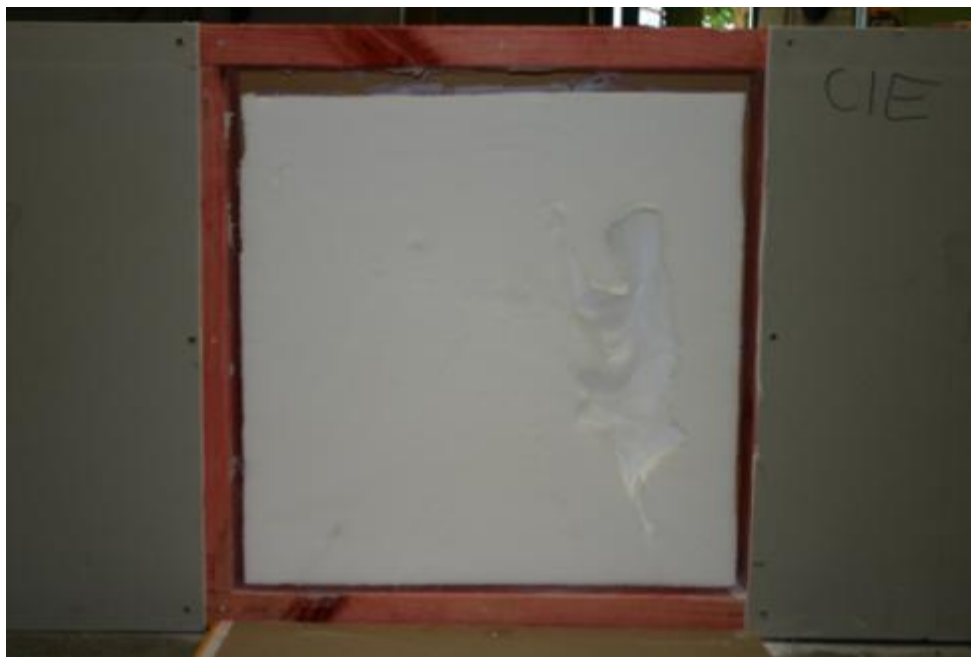
The dimensions of the fully cured UF foam in the cavities of the low walls designated C1 and C2 were also measured. The shrinkage of the samples from the rigid tubes prepared in February 2010 was measured following NZS4235 / BS5617. An average linear shrinkage of 8.97% was obtained on samples with an effective density of 11.86 kg/m³.

Figure 24: : Shrinkage in low wall C1, specimen C1D.

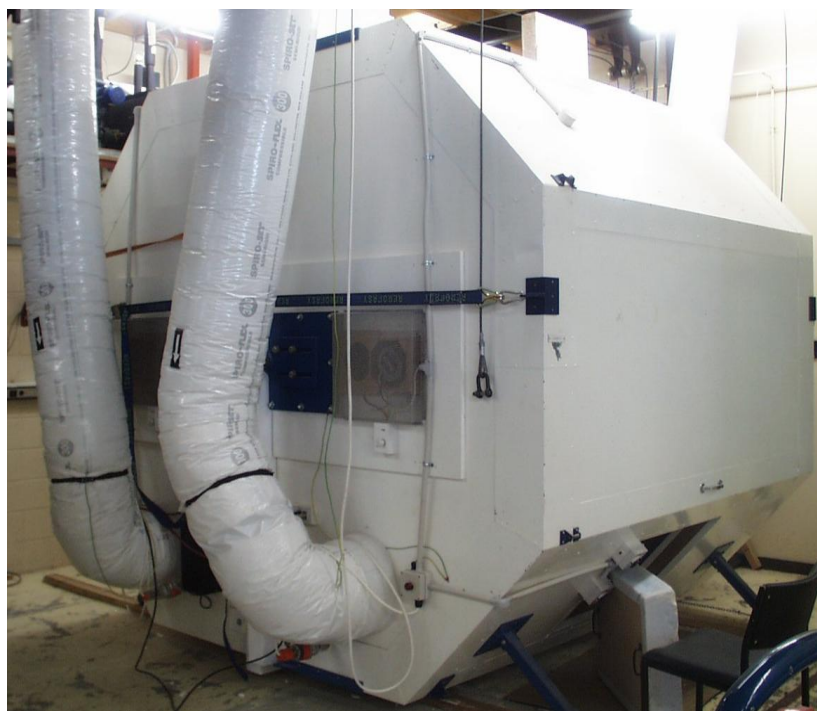
The thermal performance test for an Airfoam insulated wall was carried out using the BRANZ Guarded Hot Box (GHB), which consists of two insulated chambers of approximate face area 2.4 m x 2.4 m, with an internal depth of 1.2 m. The apparatus is constructed and operated according to ASTM C1363-97. The final R-value is determined by averaging the measurements over at least 24 hours (See Appendix 7.2 for further details).

Figure 30: Guarded Hot Box
